Appendix A Raw Water Quality

A.1 Alkalinity and hardness

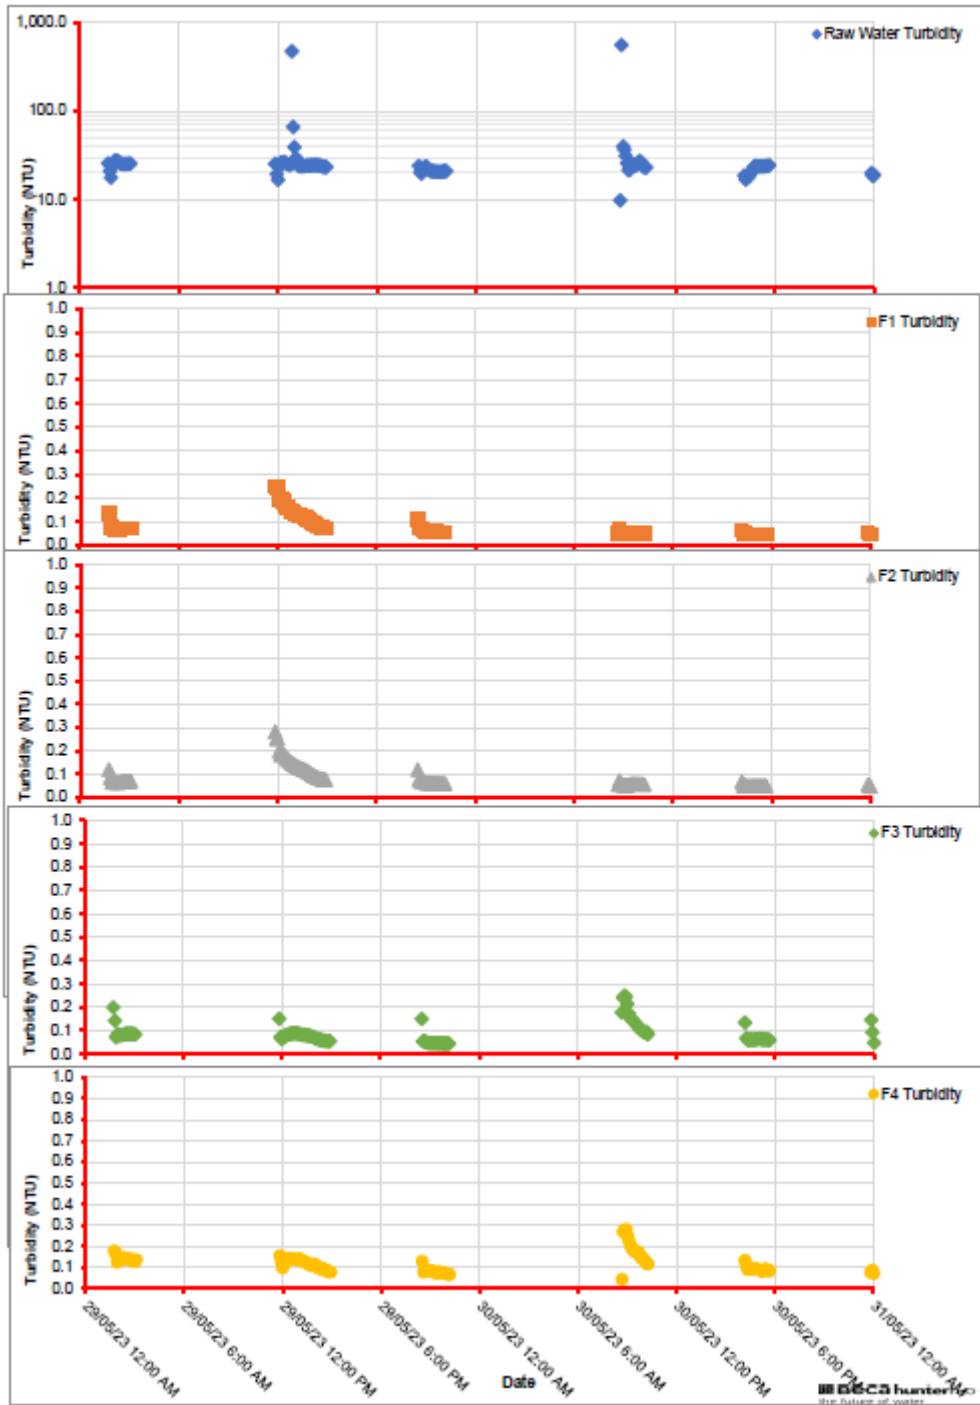
Figure B-6 Individual filter performance on 29/05/2023

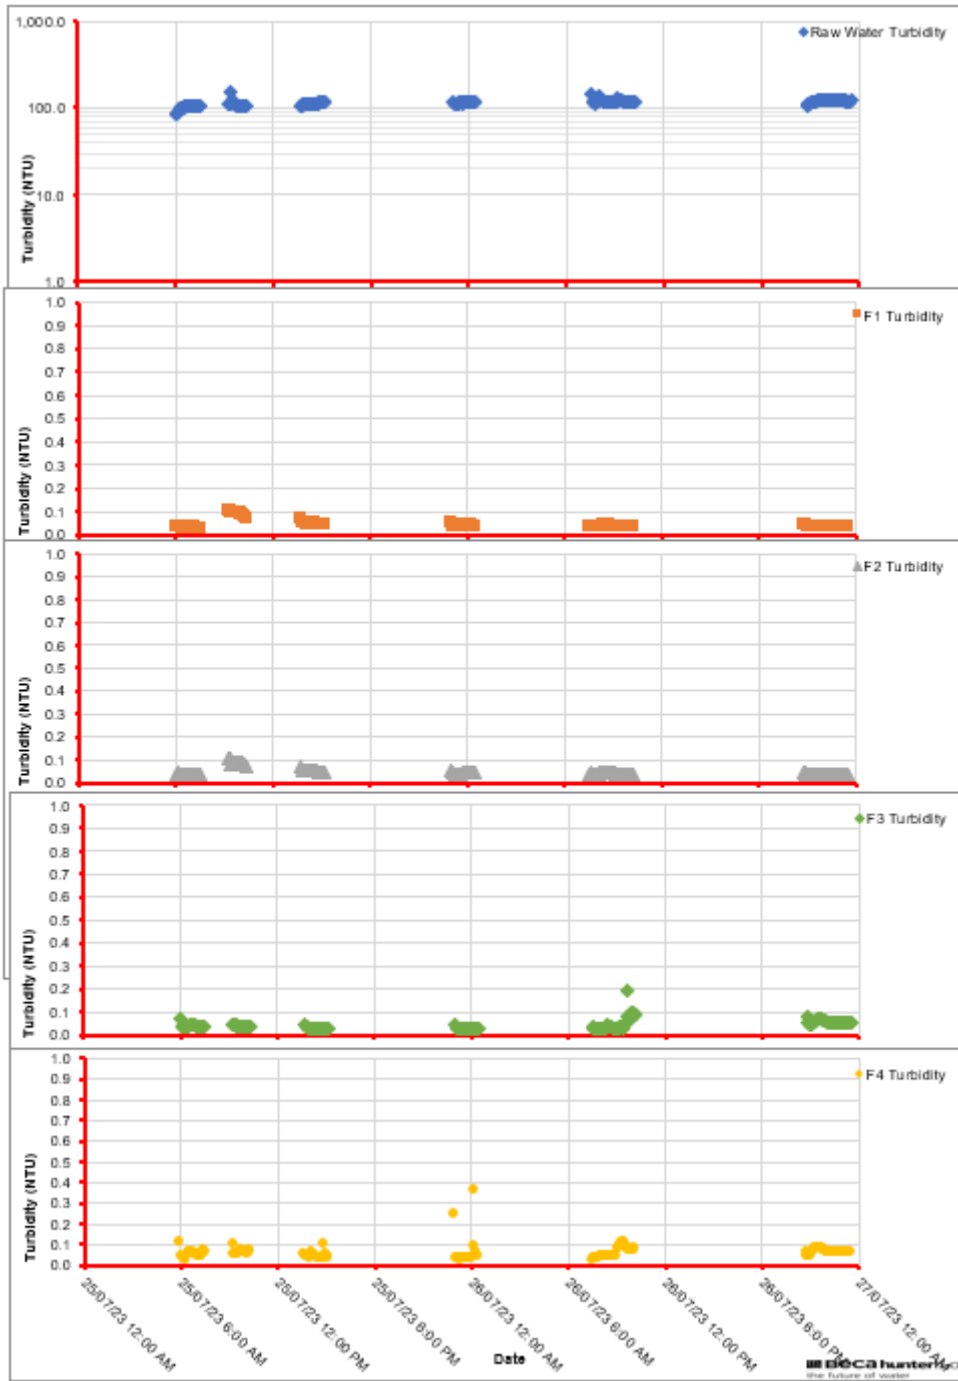
Figure B-7 Individual filter performance on 25/07/2023
