# APPENDIX G

## FLOOD AND GROUNDWATER ASSESSMENT

# Flood and Groundwater Assessment Report

ACEnergy BESS – 3 Turton Place,  
Murrumbateman, NSW

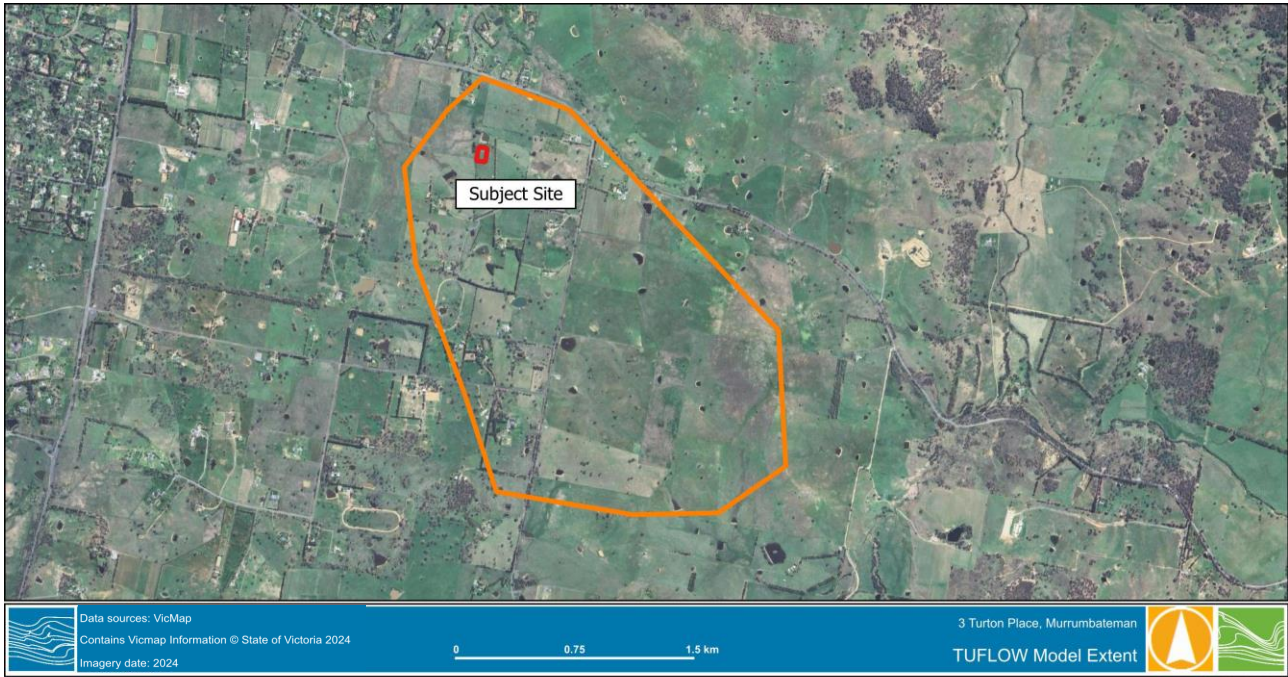
FIGURE 2-3 TUFLOW MODEL SETUP

The upstream catchment and wider area were modelled to ensure all runoff from the upstream catchment was captured. The TUFLOW model set-up and model extent is presented in Figure 2-3.
